Arboricultural Survey of Sunnybank, Mold

Gareth Buckley
Arboricultural Surveyor
Treehogs
1/12/2023

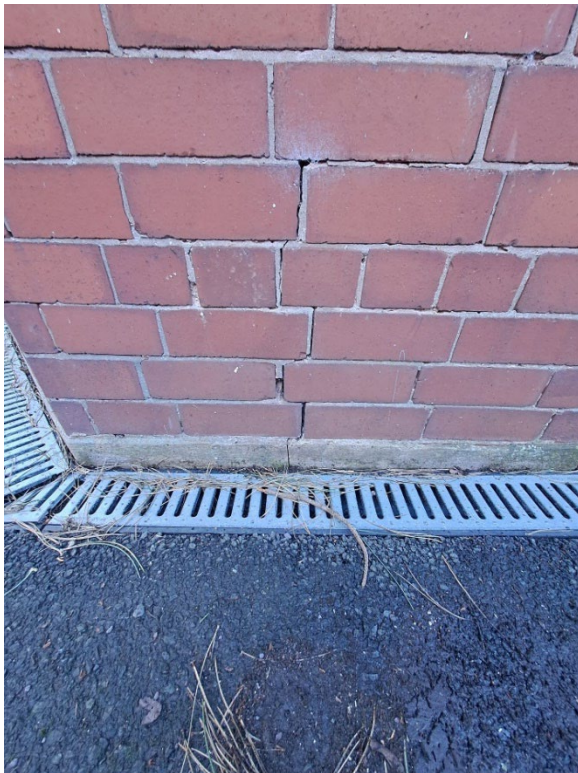
There are 2 mature Corsican pine trees in close proximity to the Grade 2 listed property of Sunnybank. While both trees are in reasonable condition as trees, they are causing significant structural damage to the building due to subsidence affecting the building foundations. This is evident from the structural cracks forming in the exterior brickwork and interior fittings of the turret section of the house, which is closest to the trees (damage shown in images 1 to 4 below). One window which used to open has had to be sealed shut due to the movement.

Image 1: Cracking in exterior wall

The only option that sufficiently reduces the risk of both limb failure and further subsidence related damage is to fell both trees to ground level. This option will enable the owner of Sunnybank to commit to reparative structural building works, secure in the knowledge that further subsidence related damage would have been prevented.

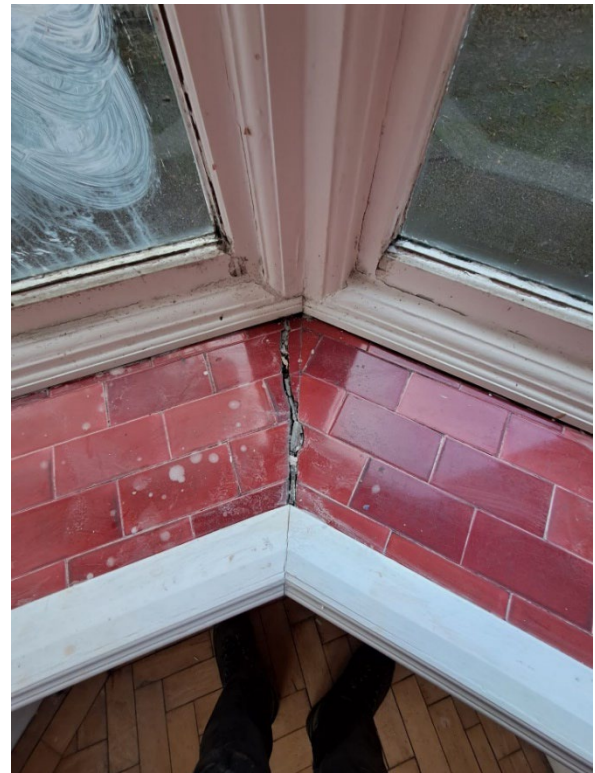
Image 2: Cracking in interior of turret room

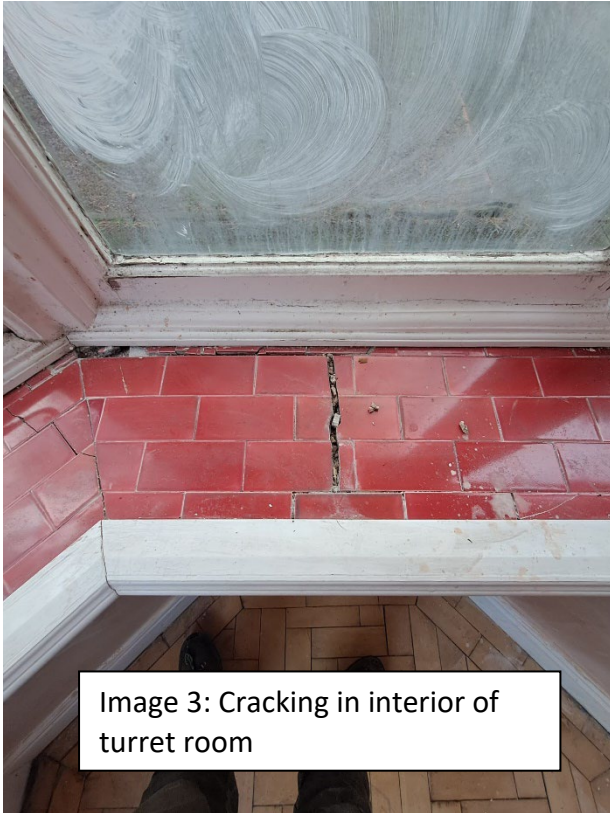
Image 3: Cracking in interior of turret room

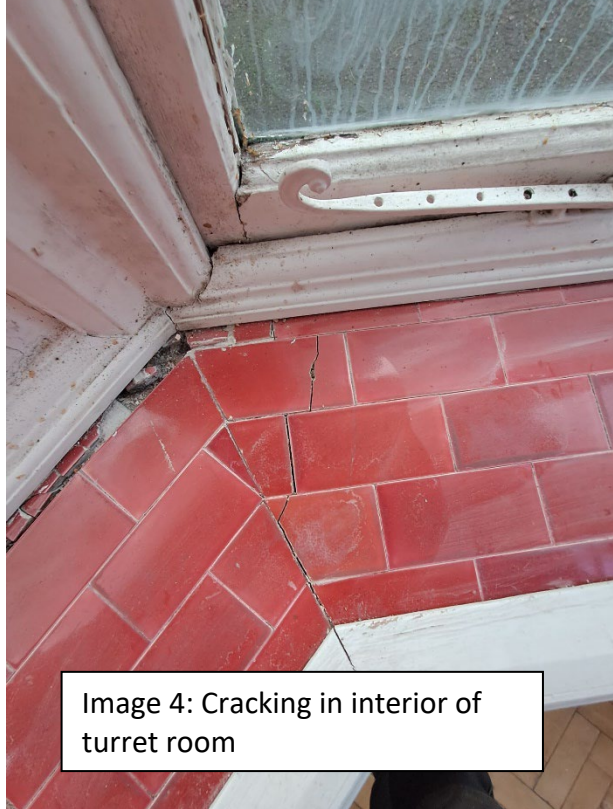
Image 4: Cracking in interior of turret room

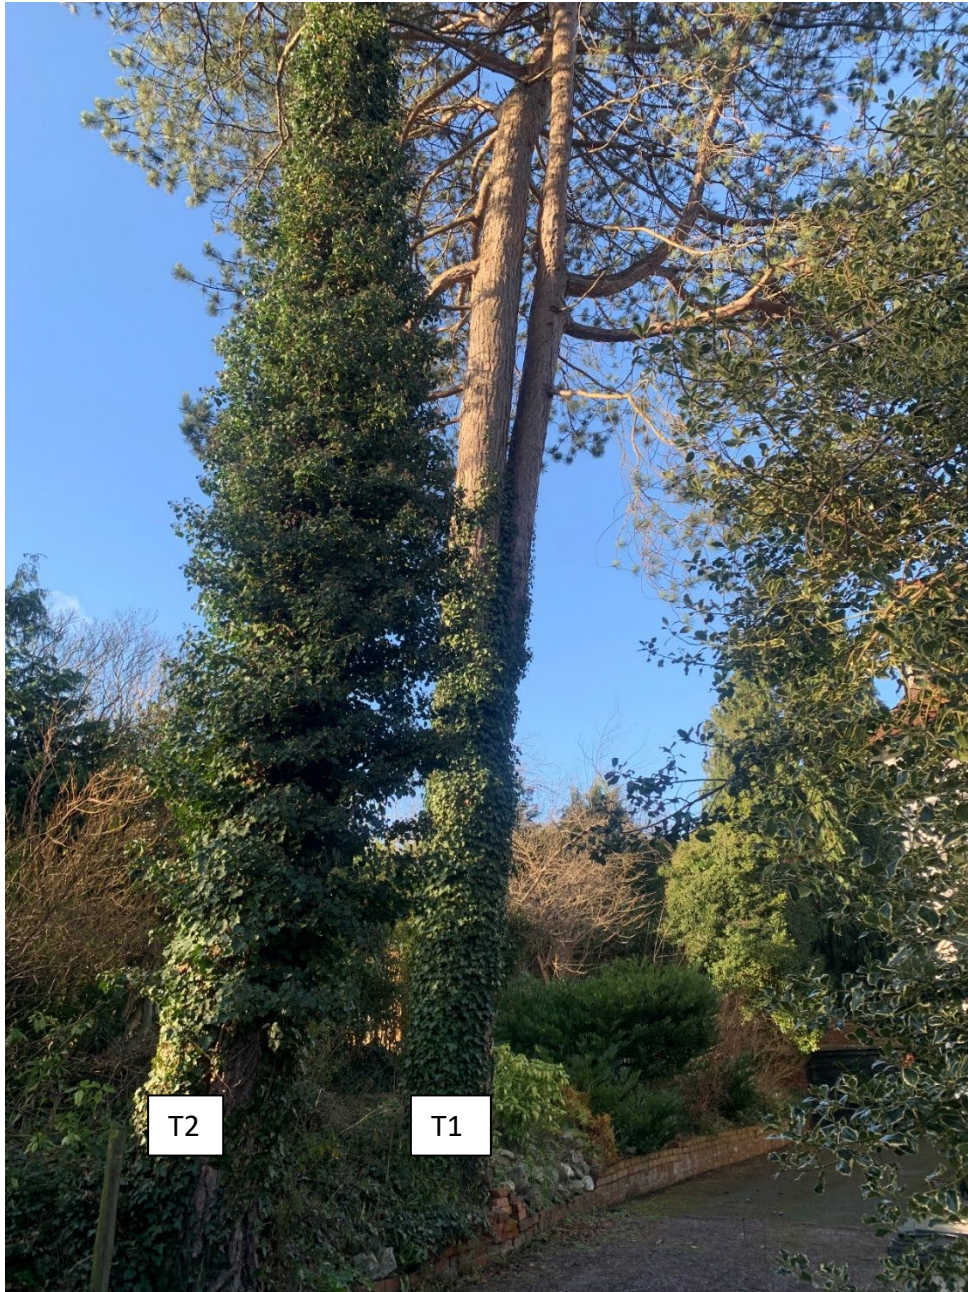
The tree closest to the house (T1) is leaning towards the house, and has a codominant stem union at approximately 8m, which is likely to be structurally weak due to a substantial amount of included bark within the union (shown in Image 5 overleaf). The weakness of this union means the tree is susceptible to major limb failure during potential storm events. In this case there would be substantial damage to the building due to the proximity between the building edge and the large stems that would be most likely to fail from the point of the branch union.

Image 5: Main stems of T1 and T2 showing codominant branch union of T1
