Sunnybank  
King Street  
Mold  
Flintshire  
CH7 1LA

**Re: Objection to Tree Preservation Order No. 345 (2023)**

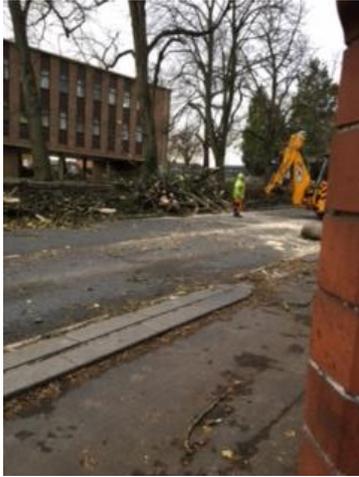
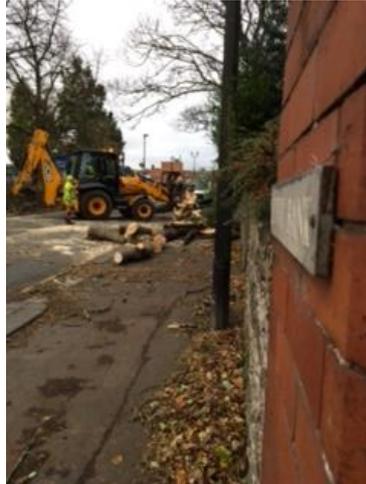
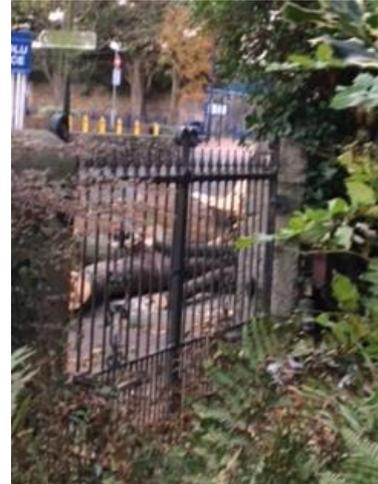
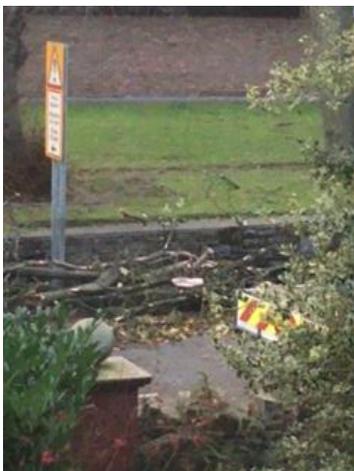
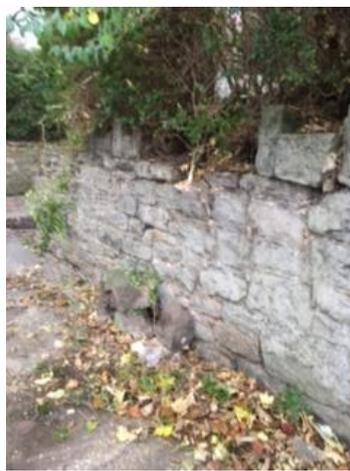
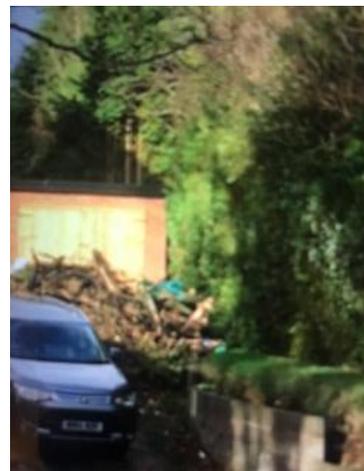
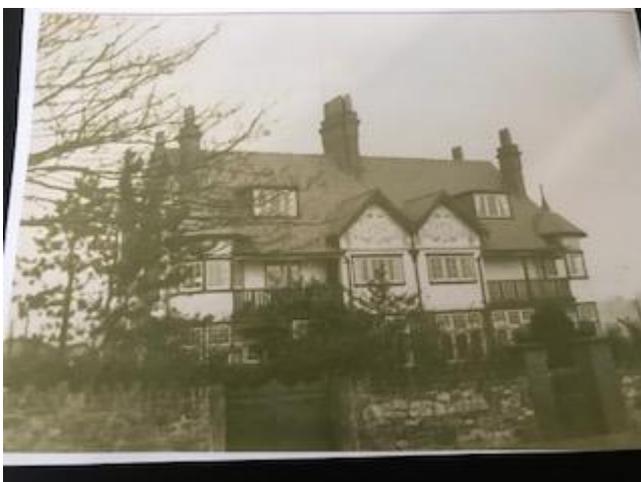
Damage on King Street roadside/outside Sunnybank following neighbouring tree fall Nov 2021

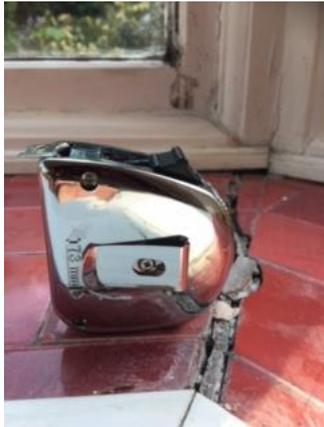
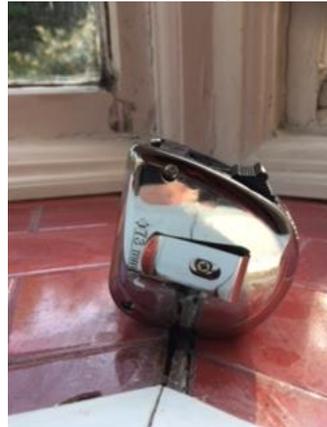
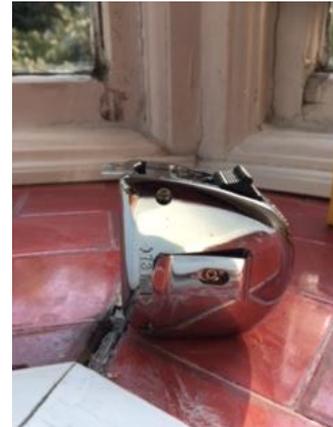
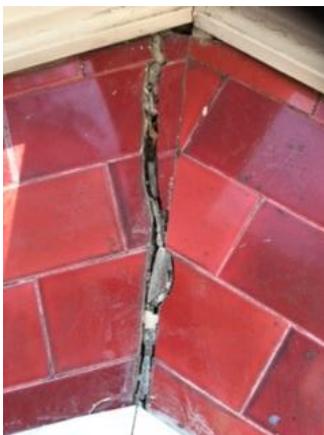
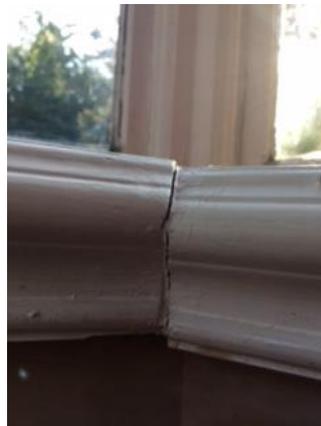
**May 2023**

Structural damage to property - During the inspection it was noted that there is significant cracking to the internal, original featured Edwardian tiled windowsills, this cracking profile corresponds to diagonal cracking to the mortar joints within the external brickwork. It was also noted that the opening window (original single glazed window) within this room no longer sits square (right) within its frame and has had to be temporarily repaired (sealed shut) to protect against further movement/structural damage.

The floor of the 'Turret' room, consists of the original parkay (wood block) flooring, which looks to be in good condition, but when applying a spirit level to the floor surface it is apparent that the floor slopes up (lifting up) to the south west corner. It was also noted that the original tiled windowsills appear to be following the same profile, with the south west corner being higher than the rest of the sill structure.

Two builders who visited the property to quote for repair to the windowsill have confirmed structural damage due to tree root activity. Roots are pushing the windowsill upwards. I can confirm that these structural cracks were not apparent when I first moved into the property in 2005 (see images)

Images of turret room with **cracks and lifting of Edwardian tiles and windowsill**

- Tape measure sits on a **higher** elevation (left side of crack in windowsill)
- Tape measure slopes on crack due to lifting
- Tape measure sits on **lower** elevation (right side of crack)
- Windowsill movement in the sill (lift/drop)

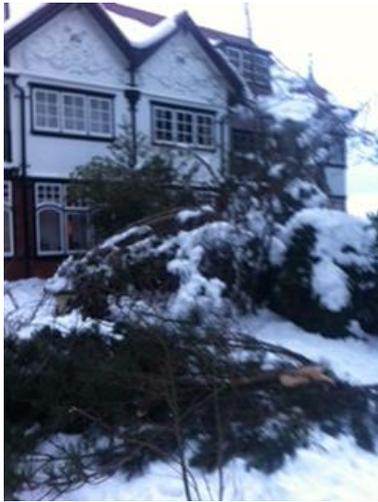
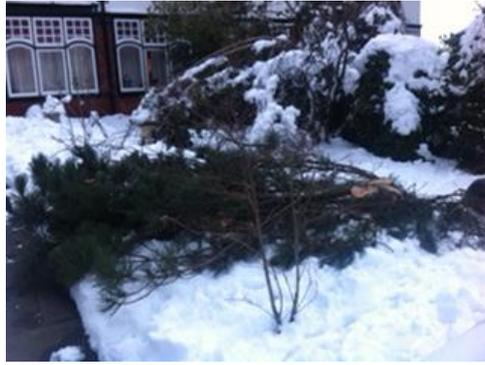
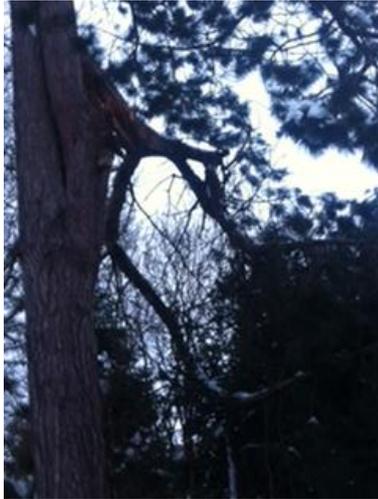
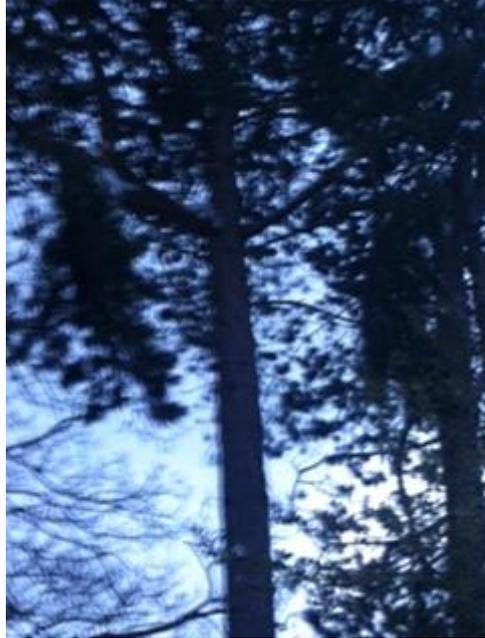
The arborist reported the tree closest to the property has a lean towards the property with multiple trunks and has a codominant stem union at approximately 8m high which is likely to be structurally weak due to the substantial amount of included bark within the union. The weakness of this union means the tree is susceptible to major limb failure during the events of high winds, heavy rain, snow, ice and storms. In March 2013 a large limb fell leaving one precariously hanging (see images)

March 2013 – following snow one large limb fell onto the driveway leaving another limb precariously hanging at height
